CENTRAL MAPPING AUTHORITY

GEODETIC SURVEY OF N.S.W.

GEODETIC STATION RECONNAISSANCE and MAINTENANCE REPORT

STATION: **DITTON** No.: **1836**

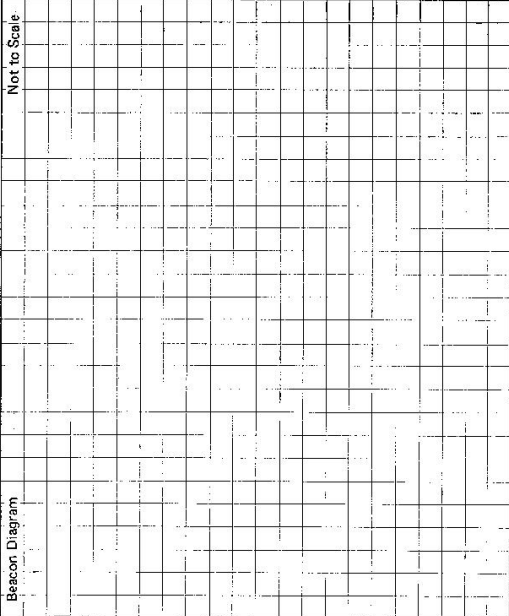
STATION DITTON D 1836	<p>Owner's Name: Address: Phone:</p> <p>Current Occupant: Address: Phone:</p> <p style="text-align: center;">ACCESS</p> <p>Access Report of 21/7/1981 was found suitable/unsuitable. Cairn only found. Mast and vanes destroyed. No marks found. Cairn in poor condition and needs rebuilding. 360° clearing necessary</p> <p style="text-align: center;">Reference Map - Burratorang 1:25 000</p>
Beacon Diagram

8. Action required:..... New mast & vanes required, 360° clearing necessary, can't be rebuilt.
