CENTRAL MAPPING AUTHORITY **GEODETIC SURVEY OF NSW** **GEODETIC STATION RECONNAISSANCE and MAINTENANCE REPORT** No.: **5886**

STATION: **BALD ROCK** MAP SHEET SCALE 1:250 000 **WARWICK**

INSPECTED BY: **M.L. Morrison** DATE: **23/10/19**

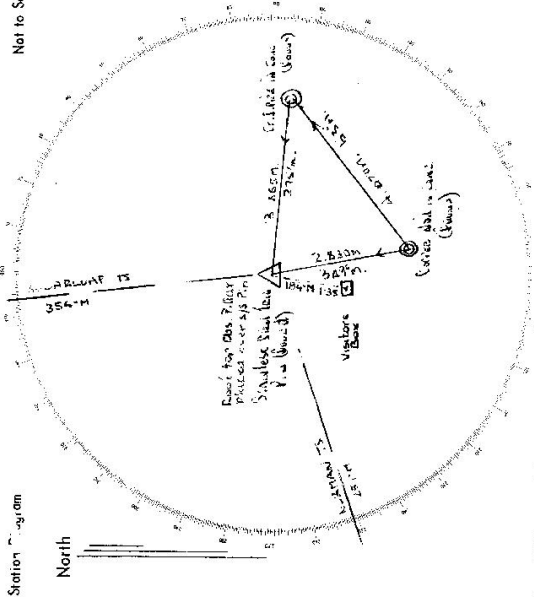
Station Diagram North Not to Scale

ROOFTOP PILLAR AS NAMES GONE MAINT BROKEN NO NAME PLATE. FD. S.I.P.P. IN CONC FD. 95m 3.86m COPPER NAIL IN CONC FOR SLIGHTLY DAMAGED. NAIL BENT OVER IN CONC AND CEMENT AROUND IT HAS BEEN BROKEN AWAY SUCCESFULLY 169m 2.83m

PILLAR NEEDS PAINTING (NO PAINT LEFT ON IT AT ALL) MAY NEED A PRIMER UNDERCOAT FIRST.

IT IS SUGGESTED THAT A STEEL MAINT VANES BE ERECTED AS THIS IS A TOURIST ATTRACTION AND IN A NATIONAL PARK.
