RECONNAISSANCE and MAINTENANCE REPORT 5-4

STATION HADDISON TS

Co: CUMBERLAND Ph: NARRABEEN.
 Map Sheet: Sydney No: 9130
 Inspected by: R LANDEL Date: 3-8-77
 Authority: C.M.A. Field Book:

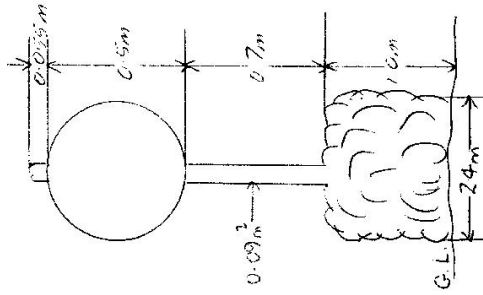
Beacon Diagram

Date: 3-8-77
 Record of Station
 CAIRN IS IN GOOD CONDITION, BUT IS
 ROTTEN VANES HAVE BEEN
 SHUT UP AND NEED REPAIRING
 VISIBILITY IS ZERO, 300° CLEARANCE
 NEEDED.
