STATION THISTLE (P) 75. 5987

Department of Lands
Integral Survey of N.S.W.
RECONNAISSANCE and MAINTENANCE REPORT 5194

GEODETTIC STATION RECONNAISSANCE and MAINTENANCE REPORT

STATION: **THISTLE GSOP** No.: **5987**

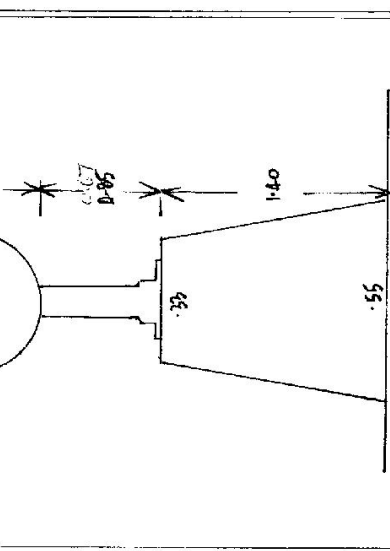
5. A. S. S. Pin set in conc./rock has been placed/rd **6.615** m, bearing **237** °M from Trig. Mast/pillar
6. ~~Cartridge Case~~ ① set in conc./soil has been placed/rd **12.146** m, bearing **238** °M from Trig. Mast/pillar

7. ~~Cartridge Case~~ ② set in conc./soil has been placed/rd **5.936** m, bearing **288** °M from Trig. Mast/pillar
8. ~~Cartridge Case~~ ③ set in conc./rock has been placed/rd **6.052** m, bearing **189** °M from Trig. Mast/pillar

9. Connection ~~SS Pin~~ to ①: **5.534** m, bearing **239** °M
10. Connection ~~SS Pin~~ to ②: **5.442** m, bearing **360** °M
11. Connection ~~SS Pin~~ to ③: **5.168** m, bearing **17** °M

12. Connection: to m, bearing °M
13. Diff. Ht. ~~Rd. Plate~~ is **1.300** m above **S.S. Pin**
14. Diff. Ht. ~~Pillar Stake~~ is **1.654** m above ~~Cartridge Case ①~~

15. Diff. Ht. ~~Pillar Stake~~ is **1.495** m above **②**
16. Diff. Ht. ~~Pillar Stake~~ is **1.638** m above **③**
