Department of Lands

Integral Survey of N.S.W.

Non-ventilating RECONNAISSANCE and MAINTENANCE REPORT

STATION **TS 201306 Pillar (10470)**

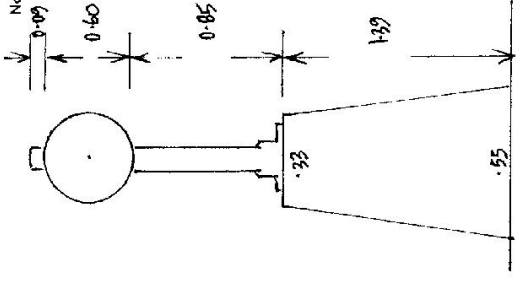
Beacon Diagram

4. The Trig. was unpiled/~~not unpiled~~, dimensions now being:
 - Description of mark: **Concrete pillar** should be explicit, e.g. Steel plug, Brass plug, Bolt, Concrete Pillar

- Height of mark: ~~1.39~~ **1.39** m ^{above}/_{below} **rock-concrete** ^{above}/_{below} G.L.
 - Height of Top Vanes to ~~Top Mast~~ Top pillar plate: **1.45** m Diameter of Vanes (vertical): **0.60** m.

- Height of Cairn: **1.32** m. Diameter of Cairn: **33 x .55** m.
 - Length of Mast: **1.54** m. (approximate if not unpiled)
5. **SSM24287** set in conc/~~rock~~ has been placed/~~is~~ **7.76** m. bearing **298**°M from Trig. ~~Mast~~ pillar

6. ~~Carrier Spike~~ set in conc/~~soil~~ has been placed/~~is~~ **6.315** m. bearing **178**°M from Trig. ~~Mast~~ pillar
7. A..... set in conc./soil has been placed/~~is~~..... m. bearing.....°M from Trig. ~~Mast~~ pillar

9. Connection: **SSM24287** to **C.S.** : **11.807** m. bearing **146**°M
10. Connection:..... to..... m. bearing.....°M
11. Connection:..... to..... m. bearing.....°M
12. Connection:..... to..... m. bearing.....°M
13. Diff. Ht. **Pillar Plate** is **1.714** m. ^{above}/_{below} **SSM24287**
14. Diff. Ht. **Pillar Plate** is **1.677** m. ^{above}/_{below} **C.S.**
15. Diff. Ht. **SSM24287** is **0.049** m. ^{above}/_{below} **C.S.**
16. Diff. Ht. is..... m. ^{above}/_{below}
