GEODETIC SURVEY OF N.S.W.

GEODETIC STATION RECONNAISSANCE and MAINTENANCE REPORT

STATION: TUMBLEDOWN	No.: 4469
MAP SHEET SCALE 1:250 000 WOLLONGONG	
INSPECTED BY: G. KEEP	DATE: 20/7/81.
AUTHORITY: C.M.A.	FIELD BOOK:

STATION TUMBLEDOWN TS 4469

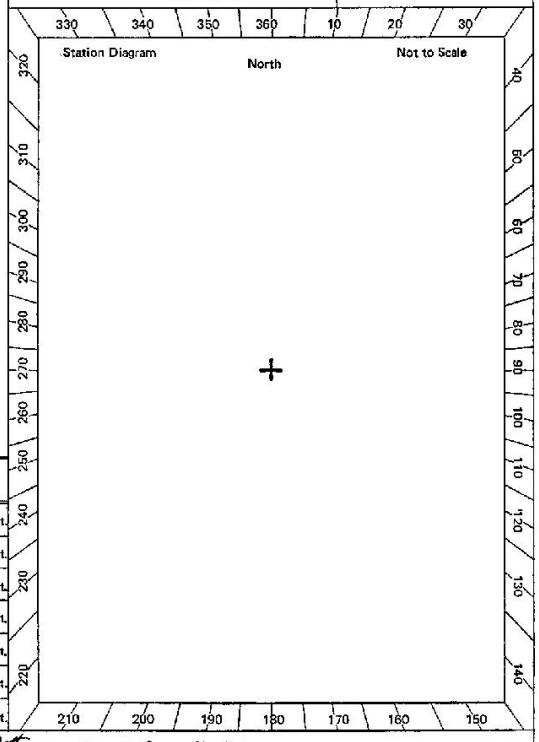
Station Diagram — North — Not to Scale

Length of Mast .....2·4.....m. (approximate if not unpiled)
4. A....G.I. pipe.....set in conc/~~rock~~ has been ~~placed~~/found, bearing....96....°M to ~~from~~ Mast/~~Plug/Pillar~~ @ 4·9 m
5. A....G.I. pipe.....set in conc/~~rock~~ has been ~~placed~~/found, bearing....39....°M to ~~from~~ Mast/~~Plug/Pillar~~ @ 9·9 m
6. A....SSM.....set in conc/~~rock~~ has been ~~placed~~/found, bearing....34....°M to ~~from~~ Mast/~~Plug/Pillar~~ @ 5·2 m
7. A.....set in conc/rock has been placed/found, bearing.....°M from Mast/Plug/Pillar
8. Action required:....360° clearing necessary.....

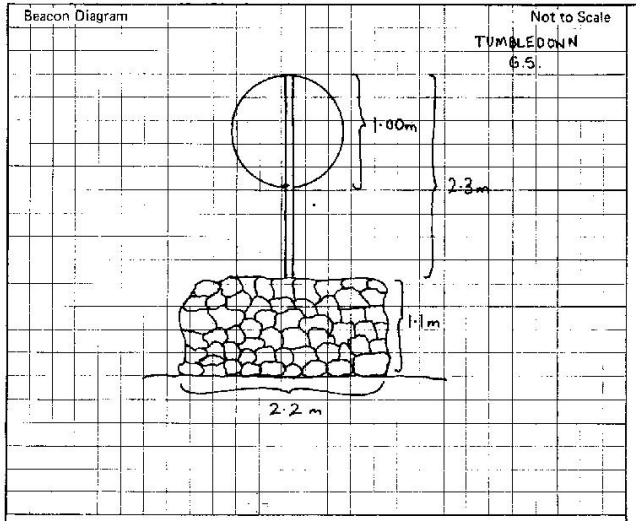
Beacon Diagram — Not to Scale

Trig. found in good condition - vanes intact & undamaged, mast straight and cairn stacked. Mast and vanes are painted black & white. 360° clearing necessary.
