LAND INFORMATION CENTRE — *GEODETIC SURVEY OF N.S.W.*

GEODETIC STATION RECONNAISSANCE and MAINTENANCE REPORT

STATION: MILE POST 180 EAST (M/POST 180 EAST RM1) — No: 7392 / No.: 7343

INSPECTED BY: G. FORD — DATE: 28/2/91

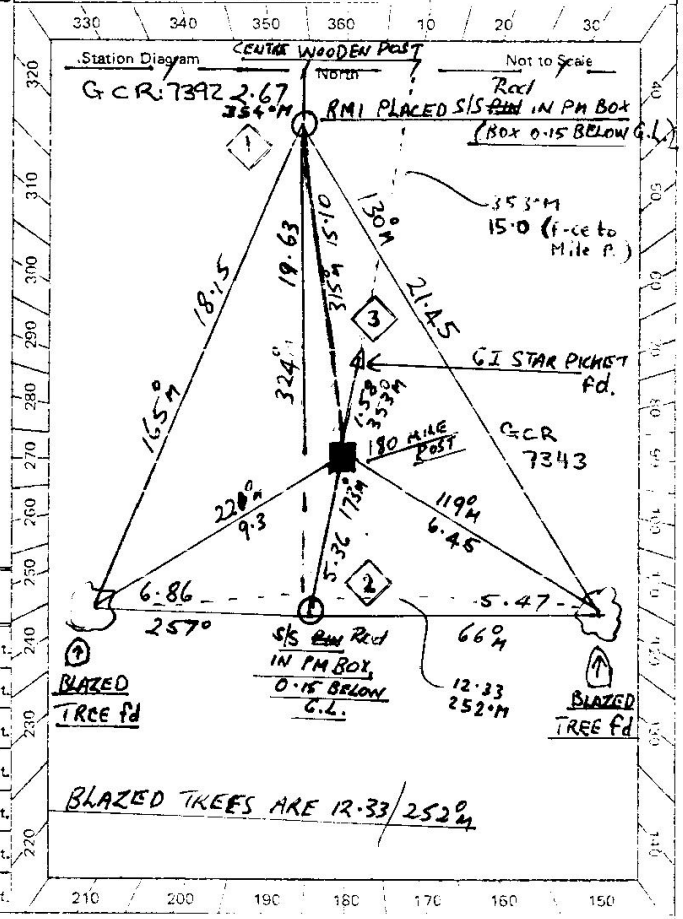
Beacon Diagram — Not to Scale

4. A S/S ~~Pin~~ Rod (RM1) set in ~~conc/rock~~ SOIL has been placed/~~found~~ UNDER COVER BOX, bearing 315 °M from ~~Mast/Plug/Pillar~~ 180 MILE POST
5. A S/S ~~Pin~~ Rod (RM2) set in ~~conc/rock~~ SOIL has been placed/~~found~~ UNDER COVER BOX, bearing 173 °M ~~from Mast/Plug/Pillar~~ TO 180 M.P.

6. A BLAZED TREE set in conc/rock has been ~~placed~~/found, bearing 226° °M from ~~Mast/Plug/Pillar~~ 180 M.P.
7. A BLAZED TREE set in conc/rock has been ~~placed~~/found, bearing 119° °M from ~~Mast/Plug/Pillar~~ 180 M.P.
   GI STAR PICKET " " SOIL " " " " 353°M " 180 M.P.
