STATION THISTLE (P) 75. 5987

Department of Lands
Integral Survey of N.S.W.
RECONNAISSANCE and MAINTENANCE REPORT 5194

GEODETTIC STATION RECONNAISSANCE and MAINTENANCE REPORT

STATION: **THISTLE GSOP** No.: **5987**

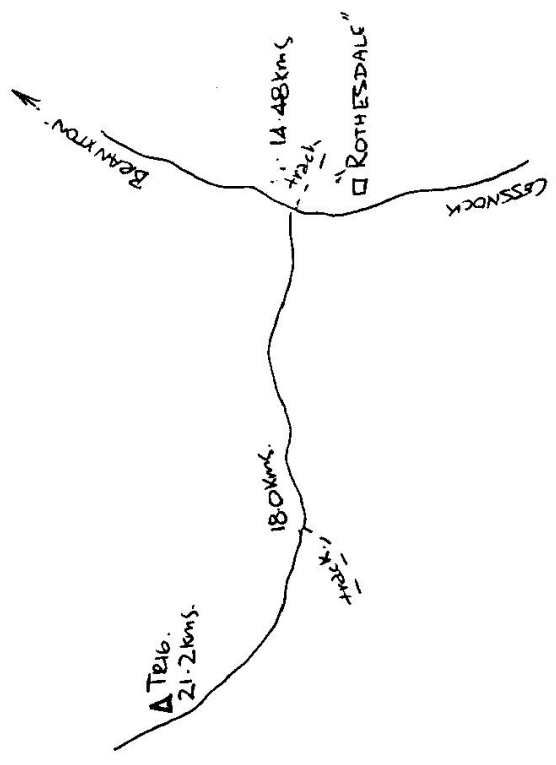
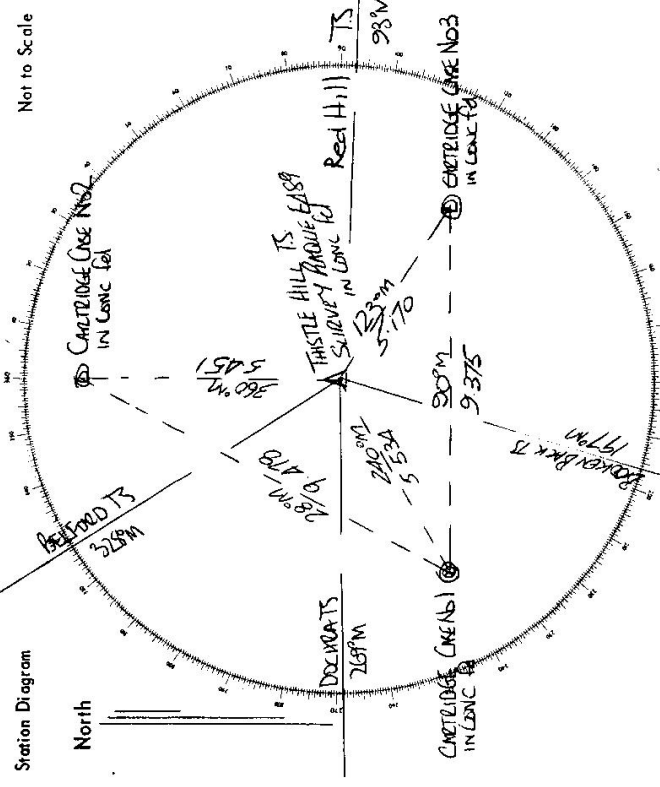
Nov 1975
 CONVENTIONAL VEHICLE (TWO MINUTE WAUK) A WHEEL DRIVE RIGHT TO TELIG.
 From "Cessnock" P.O. 0.0 km Travel North on Highway to
 BRANXTON: AT 14.48 kms. THEN LEFT AND FOLLOW THIS ROAD,
 PASSING TRACK AT LEFT, CONTINUE ON MAIN ROAD TO 21.2 kms
 TRIG APPROX 50 metres on RIGHT.
