GEODETTIC STATION RECONNAISSANCE and MAINTENANCE REPORT

STATION: **BOBLE GIGBIE** No.: **1016**

INSPECTED BY: **G. KEEP** DATE: **7-7-82**

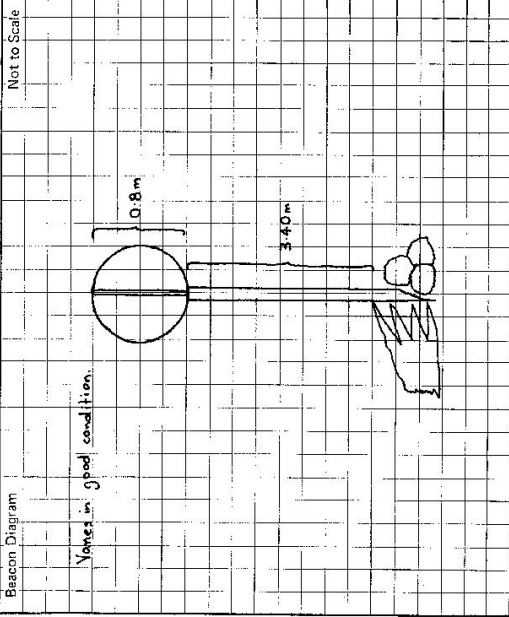
Station Diagram

Mast and vanes supported by discarded stump and some rocks. There is no visible remains of a cairn. Mast needs replacing, vanes in good condition. No plug found, no marks found. This geodetic station is situated on a low hill and requires 360° clearing of trees. For access, see Bogolong Hills 1:50,000.

8. Action required: **360° clearing of trees, complete rebuilding of station (including plug not found)**
