Department of Lands

Integrative Survey of N.S.W.
RECONNAISSANCE and MAINTENANCE REPORT

STATION TS 10696

ROXBURGH D

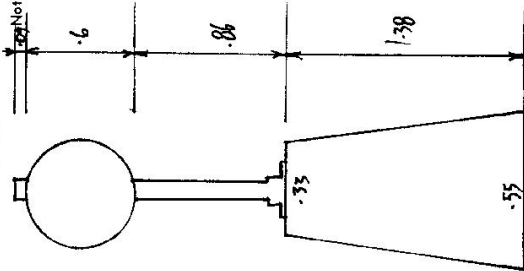
Beacon Diagram

1. Completely cleared to permit 360° vision to surrounding Trigs. ✓
2. Cleared by Jones-bearing ✓
3. Trig. Mast & Vanes have been painted white & black respectively. ✓
4. The Trig. was unpiled/~~not unpiled~~, dimensions now being:
Description of mark: Concrete pillar should be explicit, e.g. Steel plug, Brass plug, Balr, Concrete Pillar
Height of mark: 1.38 m ^{above} rock, concrete 1.38 m ^{above} G.L.

5. A 1.55 m. Diameter of Cairn 33 x .55 m.
Length of Mast 1.55 m. (approximate if not unpiled)
6. A 1.38 m. bearing 0 M from Trig. Mast/pillar
7. A 1.38 m. bearing 0 M from Trig. Mast/pillar
8. A 1.38 m. bearing 0 M from Trig. Mast/pillar
