STATION TS 10966 WICKS

RECONNAISSANCE and MAINTENANCE REPORT

STATION 10966 WICKS

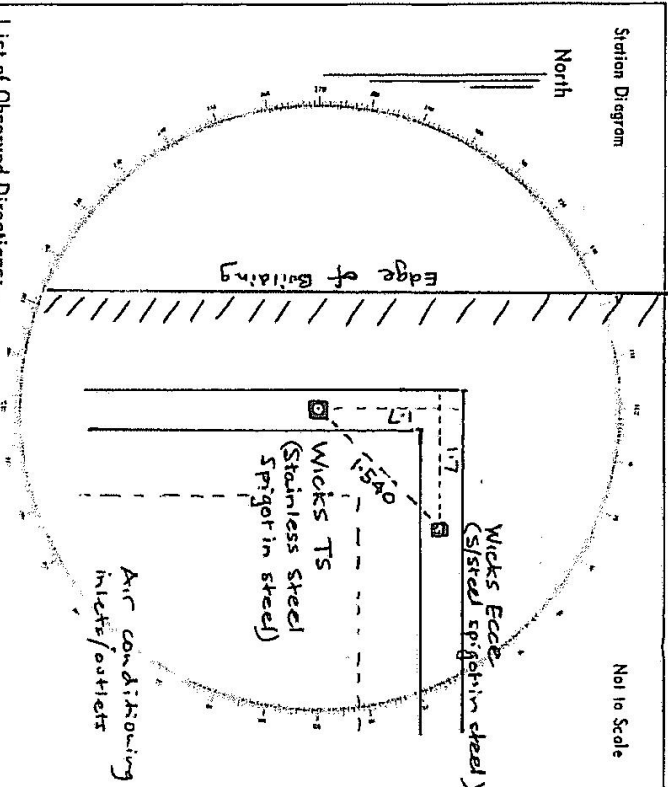
Date	Record of Field Action, Marking and Description of Station.	Reference
21-9-95	Inspected by A. Patterson <i>Entered into database 25/2/03</i>	
	<i>* NO BRACON</i>	
	Mark is Leica type stainless steel spigot in steel frame - surrounding air conditioning plant on top of roof of leica building.	
	NOTE: Heights are measured to top of spigot (NOT Steel beam).

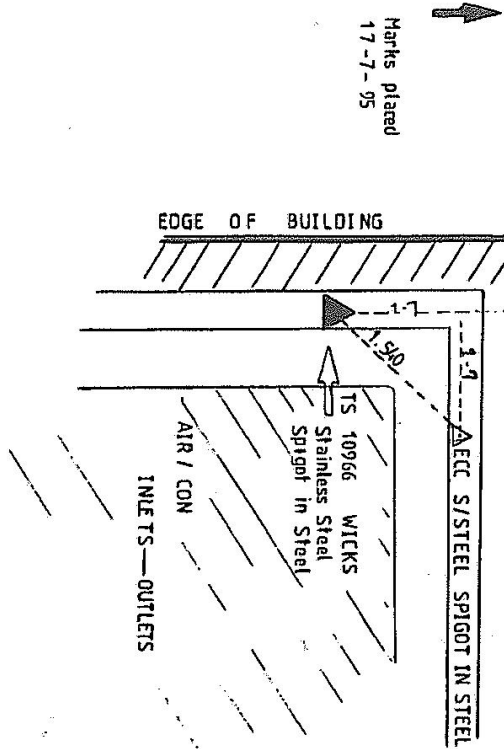
ACCESS DIAGRAM

Date	Record of Field Action Marking and Description of Station	Reference
21-8-95	Inspected by A. Patterson <i>Checked with previous spigot</i>	
	# NO BEACON	
	Mark is Leica type stainless steel spigot in steel frame surrounding air conditioning plant on top of roof of Leica building.	
	NOTE: Heights are measured to top of spigot (NOT Steel beam).

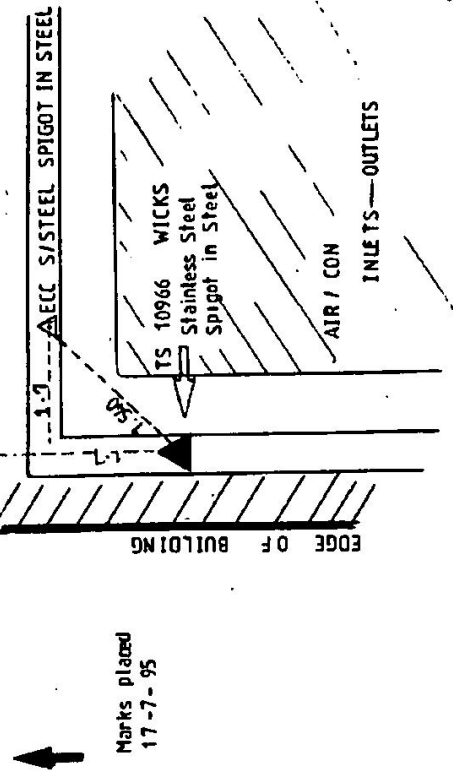
ACCESS DIAGRAM

* NO BEACON

Mark is leica type stainless steel spigot in steel frame - Surrounding air conditioning plant on top of roof of leica building.

NOTE: Heights are measured to top of spigot (NOT steel beam).

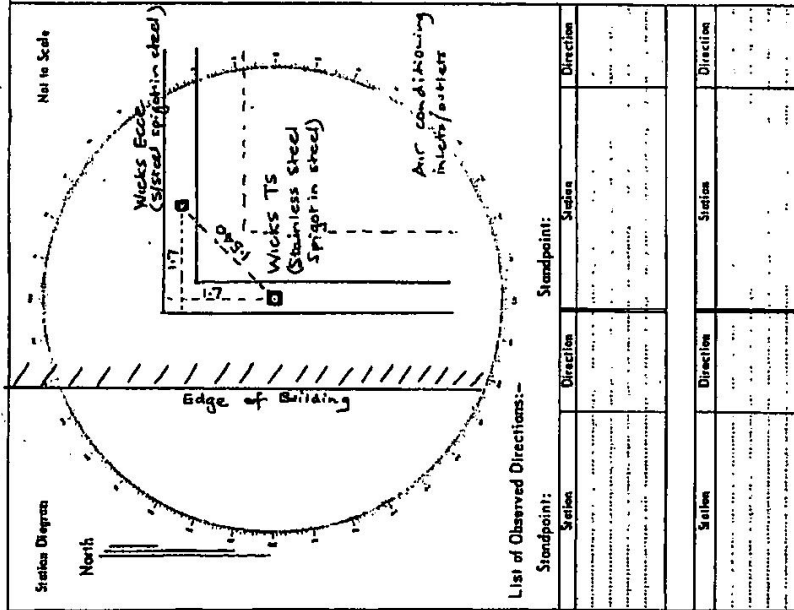
ACCESS DIAGRAM

Marks placed 17-7-95

EDGE OF BUILDING

AIR / CON

INLETS - OUTLETS

TS 10966 WICKS Stainless Steel Spigot in Steel
