STATION: MERWIN No.: E409

CENTRAL MAPPING AUTHORITY
 GEODETIC SURVEY OF NSW
 GEODETIC STATION RECONNAISSANCE and MAINTENANCE REPORT

GEODETIC STATION RECONNAISSANCE and MAINTENANCE REPORT

STATION: **MERWIN** No.: **3295**

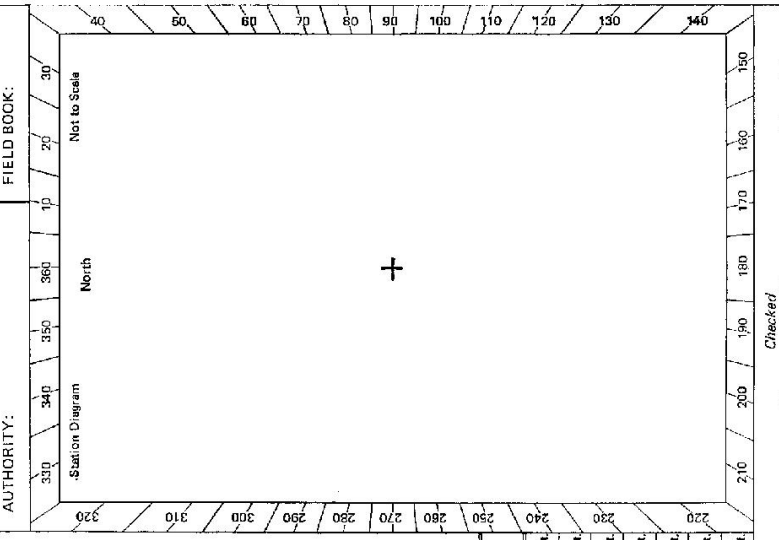
<p>Beacon Diagram</p> <p><i>Beacon is a quadrupad with 0.9m vanes Vanes have been destroyed by wind action, quadrupad is still in good order.</i></p> <p><i>Vanes are to be replaced</i></p> <p><i>Vanes scrapped out set back 1 meter 1.5m</i></p> <p>Not to Scale</p>	<p>This section to be completed by officer constructing pillar.</p> <p>Original station mark found/not found.</p> <p>Description of mark:</p> <p>Original beacon found/not found.</p> <p>Description of beacon:</p> <p>Height Top of Vanes to Top Markm.</p> <p>Height of markm. above G.L. below rock/conc.m. below</p> <p>Diameter of Vanesm. Height of Cairnm.</p> <p>Original Beacon has/not been destroyed by me.</p>

8. Action required: *Repair of vanes*
