GEODETIC SURVEY OF N.S.W.
 GEODETIC STATION RECONNAISSANCE and MAINTENANCE REPORT

STATION: **NML/53** No: **3490**

MAP SHEET SCALE 1:250 000 **NARRABRI**

INSPECTED BY: **D. FREDRIKSEN** DATE: **6/7/79**

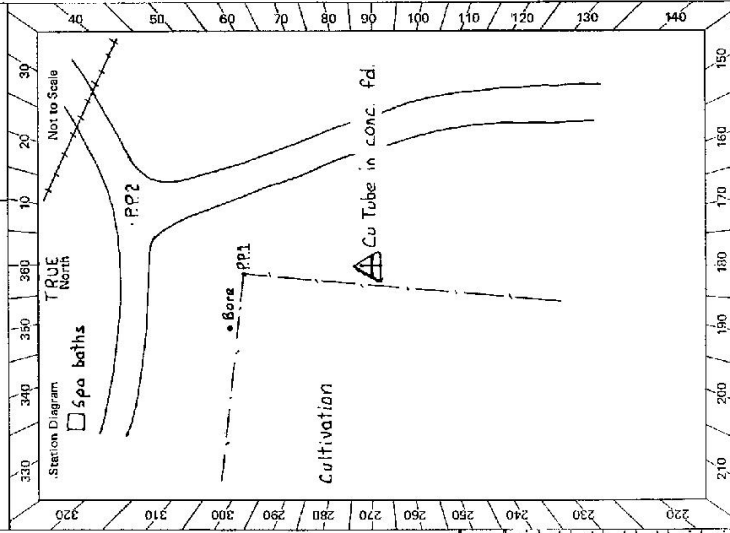
Mark	Direction	Horiz. Distance	Height Difference	Mark	Direction	Horiz. Distance	Height Difference
RM 1	6° 22'	5.934	0.075				
RM 2	95° 51'	5.994	0.125				
RM 3	187° 15'	6.011	0.210				
Fence Corner PP1	6°	53.0					
Bore 3623-1(728)	337° 37'	64.8	0.11				
Road Intersection PP2	9° 30'	121.4

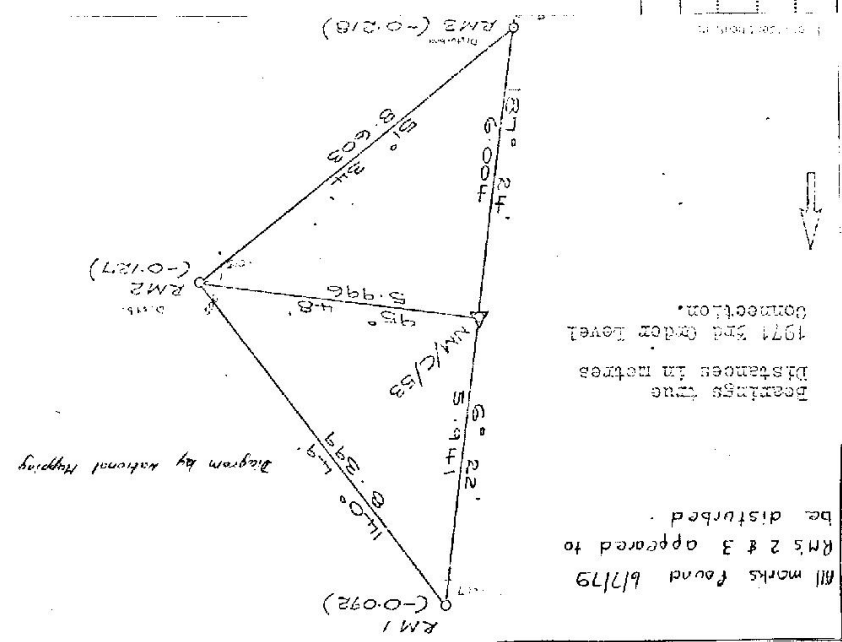
- KMS 0-0 Coronation Hotel, BURREN JUNCTION heading South towards railway
 0-2 Turn LEFT towards WEE WEA
 3-9 Turn RIGHT off main road S.P. "Bore Baths"
 4-0 Railway crossing
 4-1 Road intersection P.P.
 4-2 At NM/C/53 see sketch.
