CENTRAL MAPPING AUTHORITY

GEODETIC STATION RECONNAISSANCE and MAINTENANCE REPORT

STATION: NM/C/61 No.: 3495

MAP SHEET SCALE 1:250 000 NARRABRI

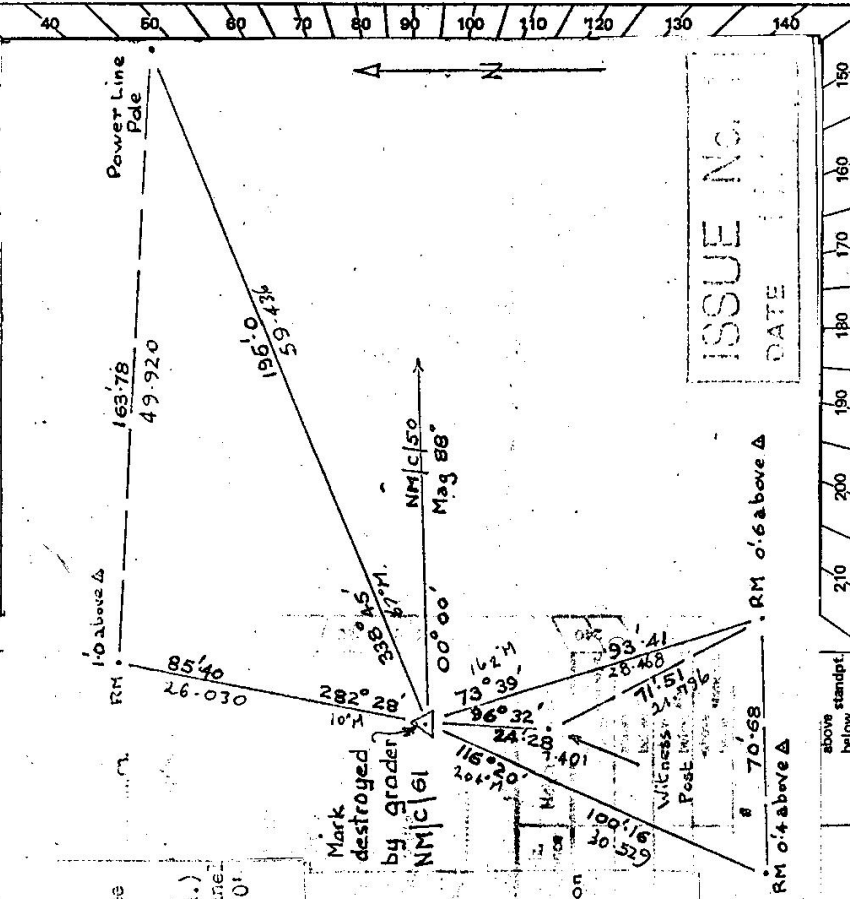
Access and Locality Sketch:

STATION MARK : A 1/2" diam. copper tube set in concrete block which is marked with the station number.

REFERENCE MARKS : Three 1/2" diam. copper tubes in concrete blocks, one 2" diam. steel witness post painted red, and a red triangle painted on a power line pole.

ACCESS : NM C 61 is close to the edge of the drainage channel on the south side of the Burren Junction-Malgett road, 9.45 miles west of Burren Junction. Views are restricted to three miles both east and west, directly along the clearing of the road. The station is on very flat terrain mostly blacksoil, with large clumps of timber. A half circular trench (12' diam.) has been dug on the south side of the mark, the drainage channel being too close on the north side to complete the circle. A 10' tower was needed for all observations and measurements.
