GEODETIC STATION RECONNAISSANCE and MAINTENANCE REPORT

STATION: *Sheeba* No.: *TS 4076*
 MAP SHEET SCALE 1:250 000
 INSPECTED BY: *J. I. Kound* DATE: *24 October 1978*
 AUTHORITY: *C.M.A.* FIELD BOOK: *DLK 1*

STATION Sheeba, G.S. TS 4076

STATION: **SHIEBA** No.: **4076**

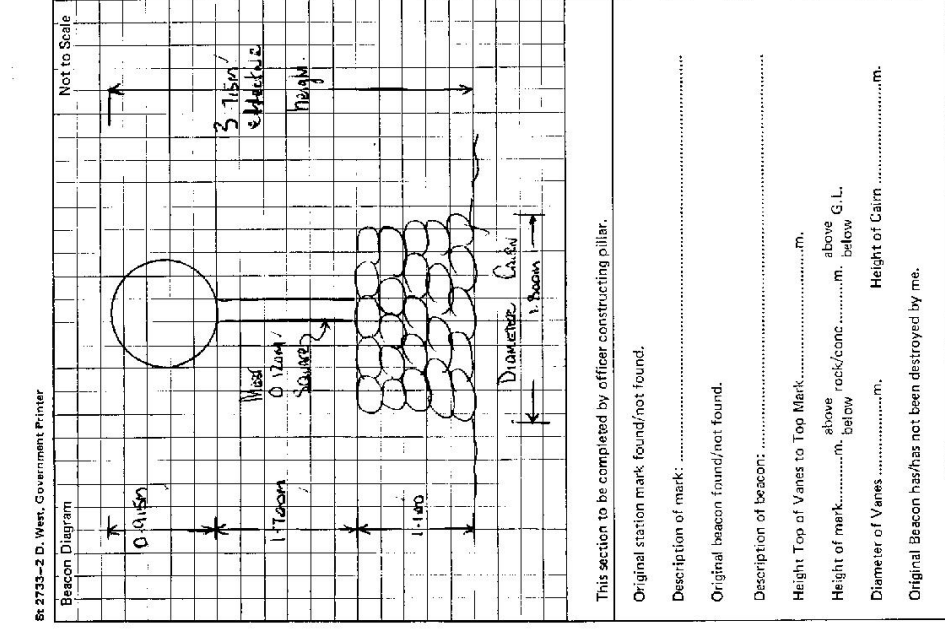
Station Diagram

4. A..... *G.I. P. Plate* set in conc/~~rock~~ has been ~~placed~~/found, bearing..... 191° M from Mast/~~Plug/Pillar~~
5. A..... set in conc/rock has been placed/round, bearing..... M from Mast/Plug/Pillar
6. A..... set in conc/rock has been placed/round, bearing..... M from Mast/Plug/Pillar
7. A..... set in conc/rock has been placed/round, bearing..... M from Mast/Plug/Pillar

Sheeba G.S. Trig. Mark only

G.I. P. in Cairn (Plate)

8. Action required: *Mast (S. Vanes) Marked. Replaced (Mast) set bearing for total clearing of hill, and the 3 piles with steel light to medium trees. Value is stopped for this but by higher interest hill, bearing So - West STANDPOINT.*
