Trigonometrical Survey of N.S.W.
RECONNAISSANCE and MAINTENANCE REPORT

STATION **TURIMETTA G.S. (PILLAR) TS 4478**

Department of Lands STATION TURIMETTA TS 4478
 RECONNAISSANCE and MAINTENANCE REPORT

GEODETIC STATION RECONNAISSANCE and MAINTENANCE REPORT

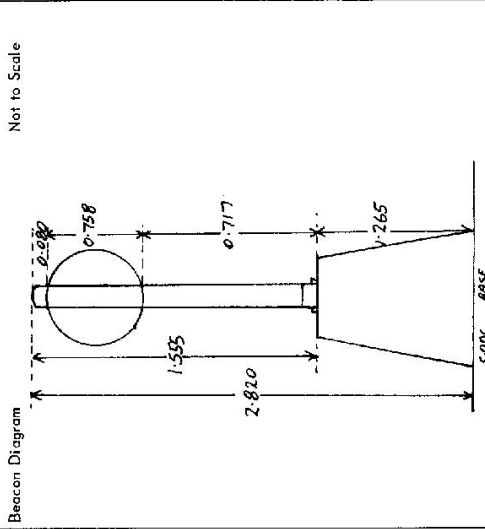
1. Completely cleared to permit 360° vision to surrounding Trigs.
2. Cleared by lones bearing..... from Trig. Mast
3. Trig. Mast & Vanes have been painted white & black respectively.
4. The Trig. was unpiled/not unpiled, dimensions now being:
Description of mark... **S/S. PILLAR PLATE** should be explicit, e.g. Steel plug, Brass plug, Bolt, G. I. Pipe
Height of mark... **1.465** m above **rock/concrete** m above **G.L.**
Height of Top Vanes to Top Mark... **1.475** m. Diameter of Vanes (vertical) **0.750** m.

5. A..... m. Diameter of Cairn..... m.
Length of Mast... **1.555** m. (approximate if not unpiled)
6. A..... set in conc/rock has been placed..... m. bearing.....°M from Trig. Mast
7. A..... set in conc/soil has been placed..... m. bearing.....°M from Trig. Mast
8. A..... set in conc/soil has been placed..... m. bearing.....°M from Trig. Mast

Date	Record of Station
5-8-75	NEW MAST & VANES ERECTED

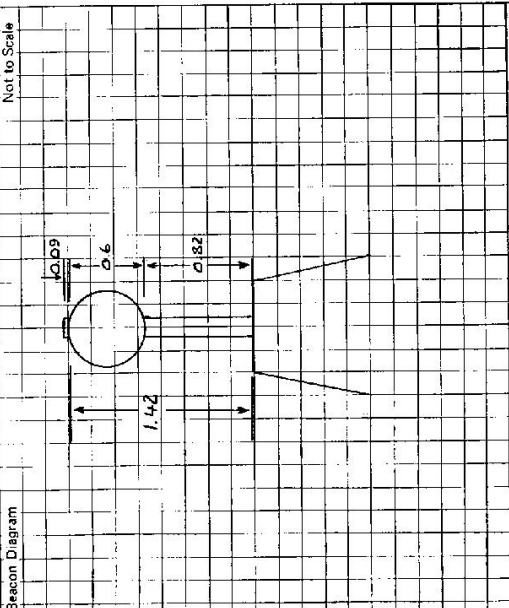
STATION TURINETTA (P)	Owner's Name: Address: Phone: Current Occupant: Address: Phone: ACCESS Access Report of/...../19.....was found suitable/unsuitable.
Beacon Diagram Not to Scale

This section to be completed by officer constructing pillar. Original station mark found/not found. Description of mark: Original beacon found/not found. Description of beacon: Height Top of Vanes to Top Markm. Height of markm. above G.L. below rock/concm. below Diameter of Vanesm. Height of Cairnm. Original Beacon has/has not been destroyed by me.
Date 26.10.53	Record of Station Mast and vanes placed by Surveyor General, British Colonial, South Africa

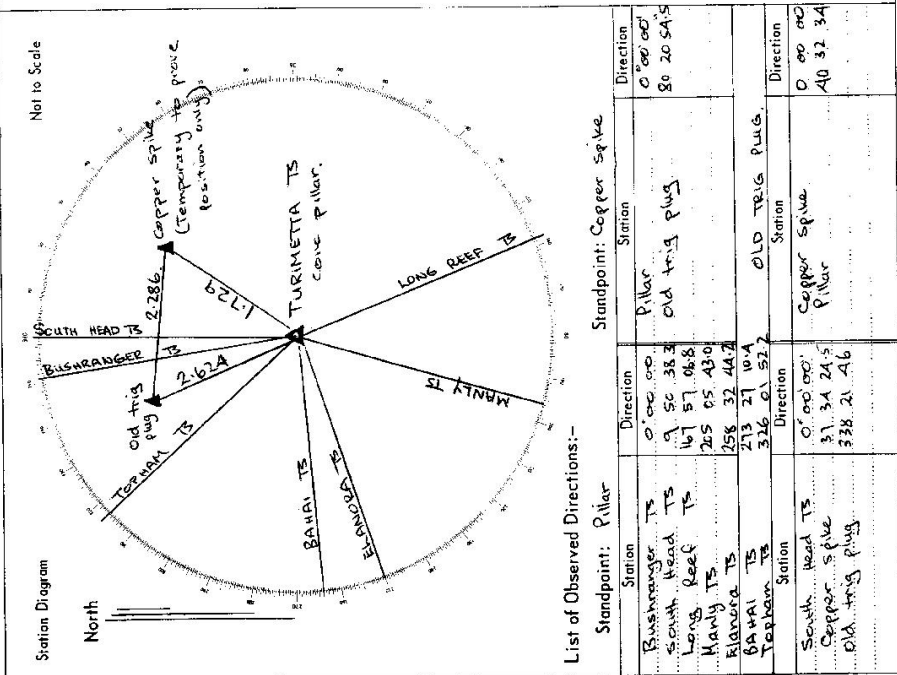
Access 23/3/1977 ON TURIMETTA HEAD NORTH NARRABEEN
 UED MAP 18 D5.
 From Narrabeen Park Rd, Narrabeen, turn east onto track just south of Turimetta Head, 2 WD to TS.
