Integrated Survey of N.S.W.
RECONNAISSANCE and MAINTENANCE REPORT
 STATION **ENGADINE (P)** TS **6039**
 Co: _____ Ph: _____
 Map Sheet: _____ No: _____
 Inspected by: _____ Date: _____
 Authority: _____ Field Book: _____
 Beacon Diagram: _____ Not to Scale

STATION Engadine Res. (new) Centre Pillar

Department of Lands
 Integration of N.S.W.
 RECONNAISSANCE and MAINTENANCE REPORTS
 STATION ENGINE PPTS 6039

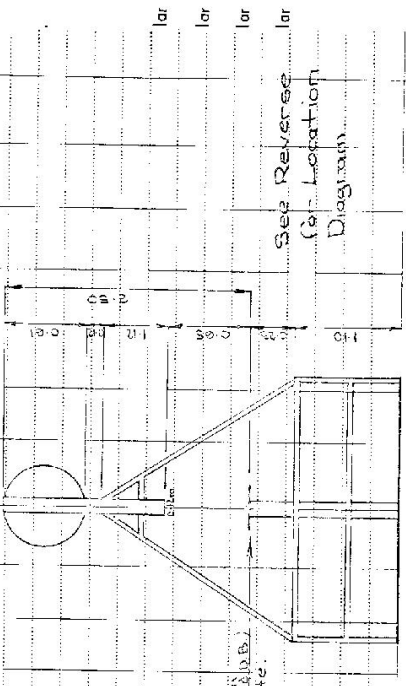
To	RL (metres)	Direction or Vert. Angle	Observer	Date	Inst.	Maintained at	Date of Pillar
RL 207.40m (S.M. Dist. 221-74)							
Top of Obs. Plate							
J. N.Y.K. 221-74							
LB-1018

All heights corrected to centre
 SEE REAR OF CARD FOR REMARKS

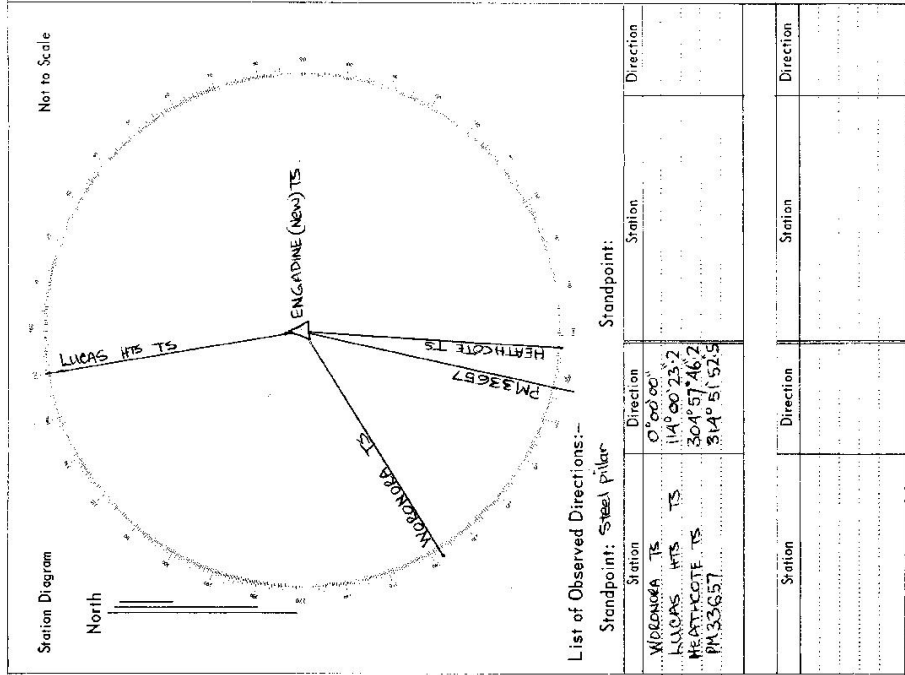
16/9/1975
Access On Old Princes Highway in Engadine Shopping centre.
