GEODETIC STATION RECONNAISSANCE and MAINTENANCE REPORT

STATION: *Site "A" (444-889)* No: 6745

STATION **Balaibuan 6748***

STATION Balabulua Conc. obs. Pillar 6748

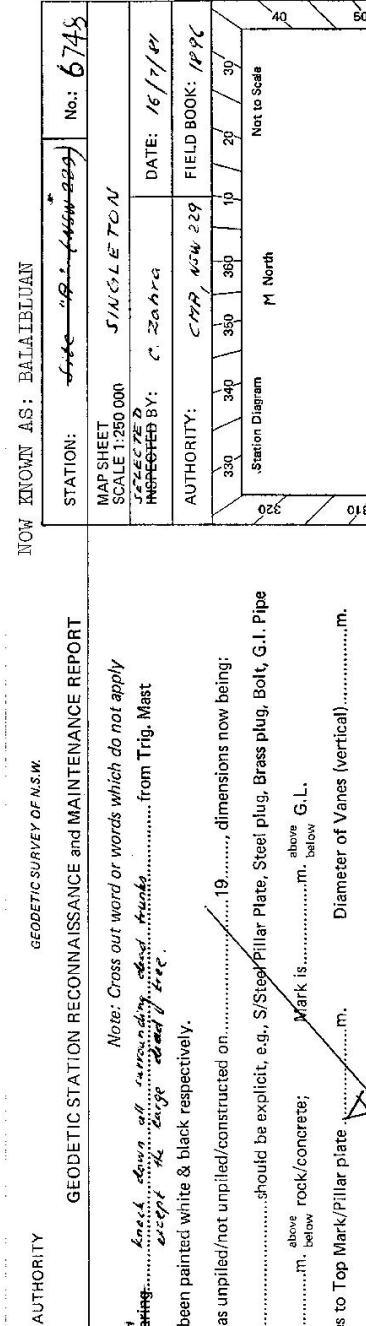
Station Diagram M North

Mark	Direction	Horiz. Distance	Height Difference	Mark	Direction	Horiz. Distance	Height Difference
Balkan	0 00 00		above standpt	Henderson	157 18 06		above standpt
Arthur	9 04 33		above standpt	Henderson	203 30 46		above standpt
Denman N. Pt.	40 47 24		above standpt	Myialungh	228 43 38		above standpt
Ogilvie	22 45 11		above standpt	Myal (approx)	300		above standpt
Dangar	74 24 22		above standpt	Roscoe	341 26 07		above standpt
Gundabri approx	143 55		above standpt	Twin dead trunk	182		above standpt
Watt	144 41 00		above standpt	Large dead tree	172 30		above standpt

8. Action required: *Construct pillar. Place 2 red marks. Clear trees on intermediate ridge on line to Gundabri. See report for details.*
