GEODETTIC SURVEY OF N.S.W.

GEODETTIC STATION RECONNAISSANCE and MAINTENANCE REPORT

STATION: COONEY G.S. (P) No.: 7253  
 MAP SHEETS SCALE 1:250,000 COORAMUNDRA  
 INSPECTED BY: L. MITCHELLS DATE: 5-6-86  
 AUTHORITY: C.M.A. FIELD BOOK: C 381 ✓

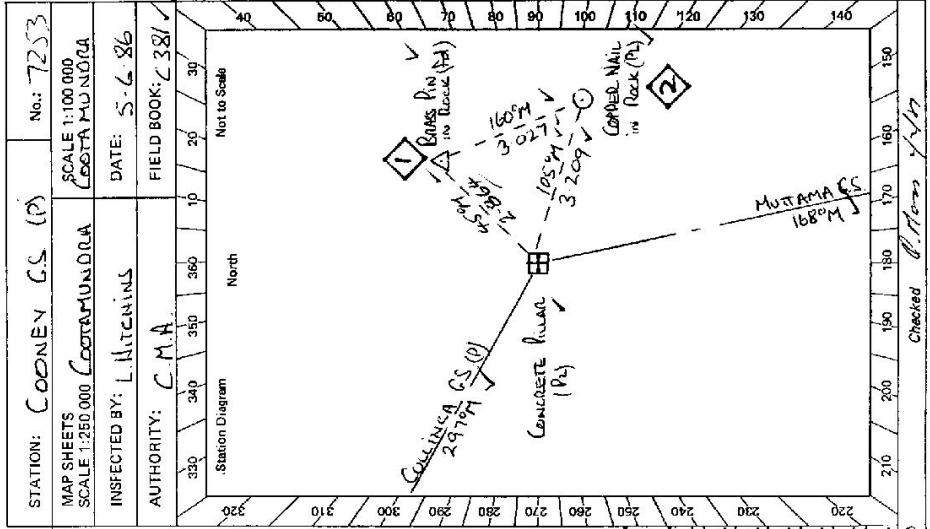
1. Cleared by lanes bearing  $360^\circ$  except for 5 K.I. trees.  Note: Cross out word or words which do not apply  
 6 Gums + 1 K.I. trees have been felled.  from Trig. Mast  
 6 Gums + 1 K.I. trees have been felled.  No SUFFERING SHOULD BE NEEDED ✓

2. Mast & Vanes have been painted white & black respectively.
3. The station/pillar was ~~re-erected~~  constructed on  $441$   $50$   $19.86$  ✓, dimensions now being:  
 Description of mark  $1.520$  ✓ should be explicit, e.g., S/Steel Pillar Plate, Steel plug, Brass plug, Bolt, G.I. Pipe  
 Height of mark  $1.520$  ✓ m. above ~~rock/concrete~~  rock/concrete; Mark is  $1.520$  ✓ m. above G.L.  
 Height of Top Vanes to Top Mark/Pillar plate  $1.440$  ✓ m. Diameter of Vanes (vertical)  $0.750$  ✓ m.  
 Height of Cairn  $0.750$  ✓ m. Diameter of Cairn  $0.750$  ✓ m. Name Plate ~~found~~  found/placed.  
 Length of Mast  $0.750$  ✓ m. (approximate if not unpiled)

4. A. ~~BRASS TRIG. PIN~~  set in ~~conc~~  rock has been placed/found, bearing  $45$  ✓ ° M from Mast/Plug/Pillar
5. A. ~~COPPER NAIL~~  set in ~~conc~~  rock has been placed/found, bearing  $105$  ✓ ° M from Mast/Plug/Pillar

6. A.  set in ~~conc~~  rock has been placed/found, bearing  $105$  ✓ ° M from Mast/Plug/Pillar
7. A.  set in ~~conc~~  rock has been placed/found, bearing  $320$  ✓ ° M from Mast/Plug/Pillar

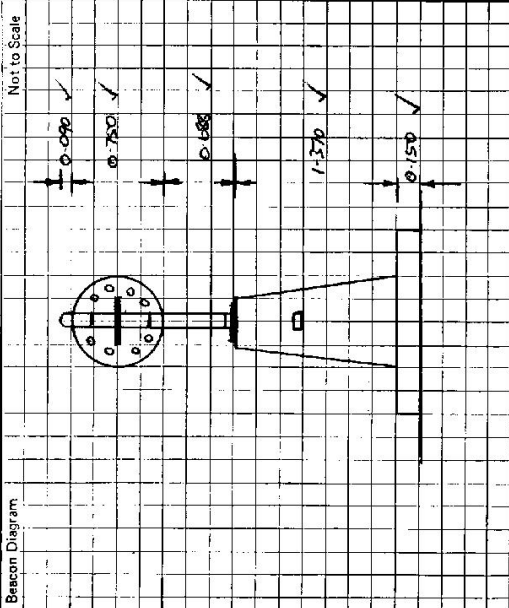
Original station mark found/~~not found~~.  
 Description of mark: **Recessed brick pin in rock** ✓  
 Original beacon found/~~not found~~.  
 Description of beacon: **Cairn** ✓  
 Height Top of Vanes to Top Mark: **3.750** **APPROX** ✓  
 Height of mark: **0.5** **above rock/cont.** **0.750** **above G.L.** ✓  
 Diameter of Vanes: **0.150** ✓ Height of Cairn: **1.750** ✓  
 Original Beacon has ~~been~~ been destroyed by me. ✓
